**Boeing Plant 2
Seattle, Washington**

Phase II Transformer PCB Investigation Report

August 3, 2005

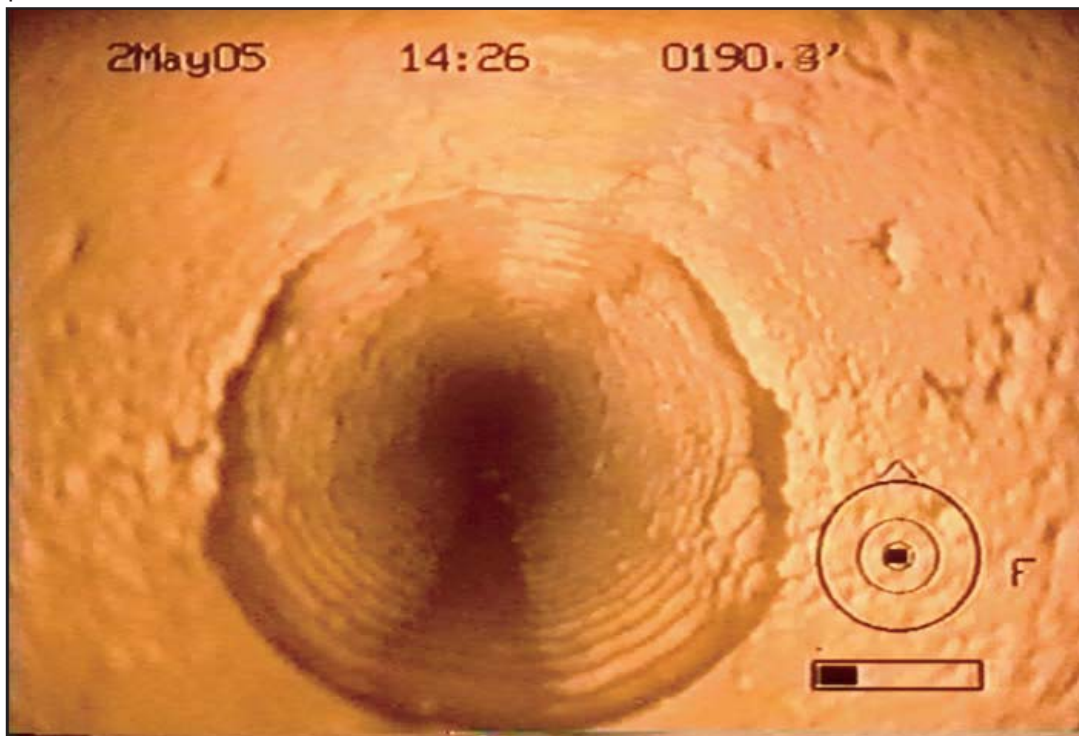
photo 4

View of 12-inch concrete Property Line storm pipe change to CMP; located 190.3 feet west of SDMH 15A.

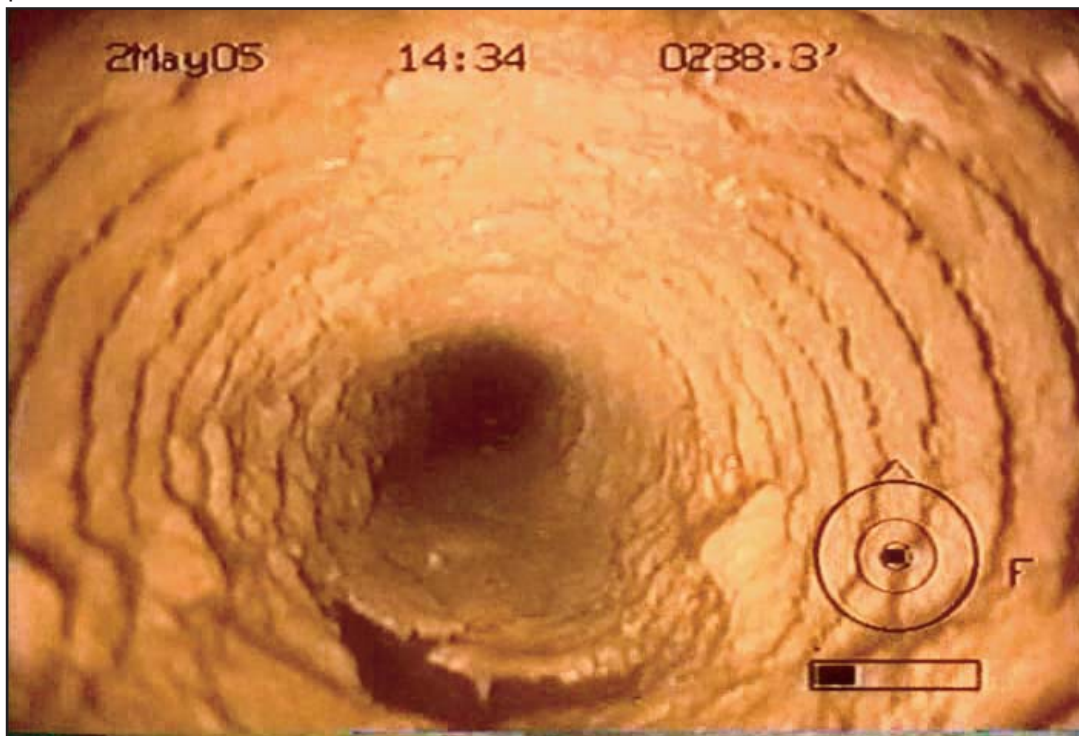
photo 5

End of video survey on 12-inch CMP Property Line storm pipe due to hole in pipe; located 238.3 feet west of SDMH 15A.

- Each storm system was found to be intact (upon review of the video) and have integrity (i.e., no broken, severely cracked, or missing sections of pipe were found) except for both Property Line Storm Pipes at a point just prior to their outfalls where a significant separation of the corrugated metal pipe was observed that prevented further survey.

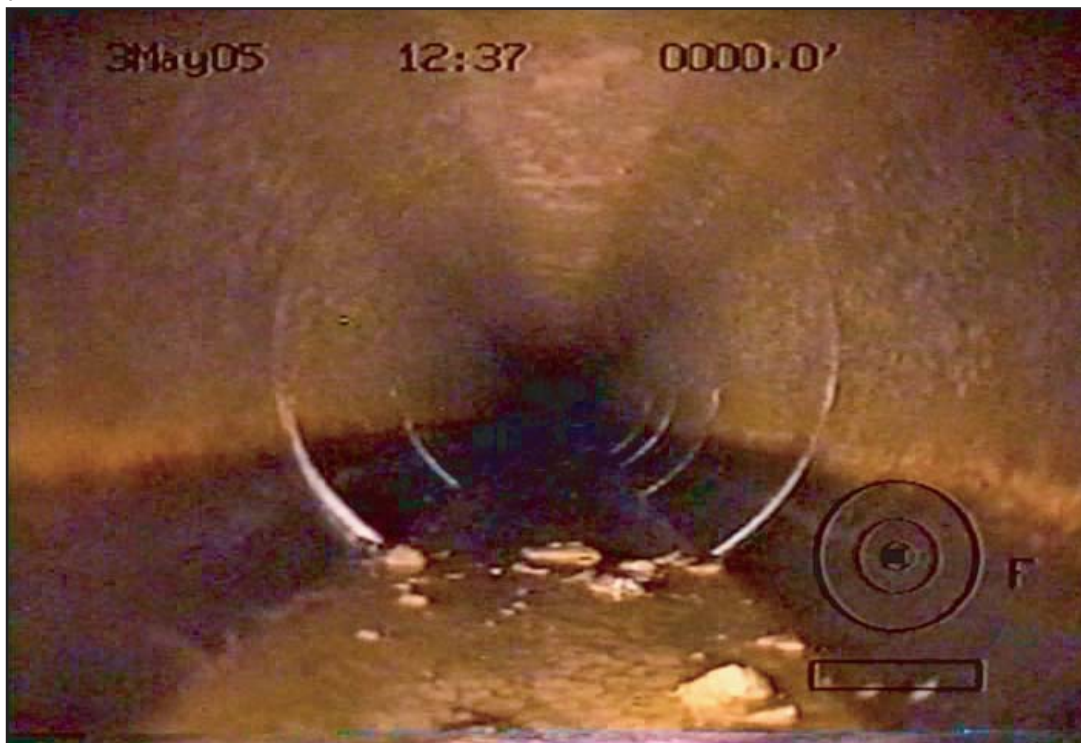
photo 6

View from SDMH 24A facing west in 24-inch concrete Property Line storm pipe.

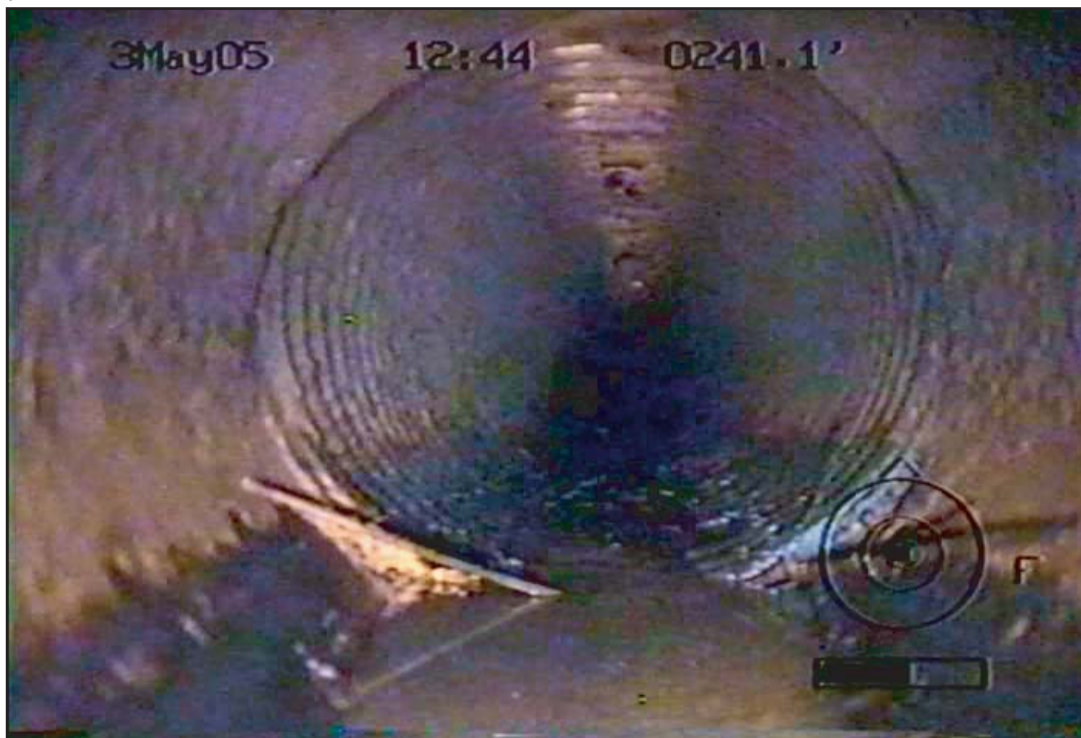
photo 7

View of 24-inch concrete Property Line storm pipe change to CMP; located 241.1 feet west of SDMH 24A.

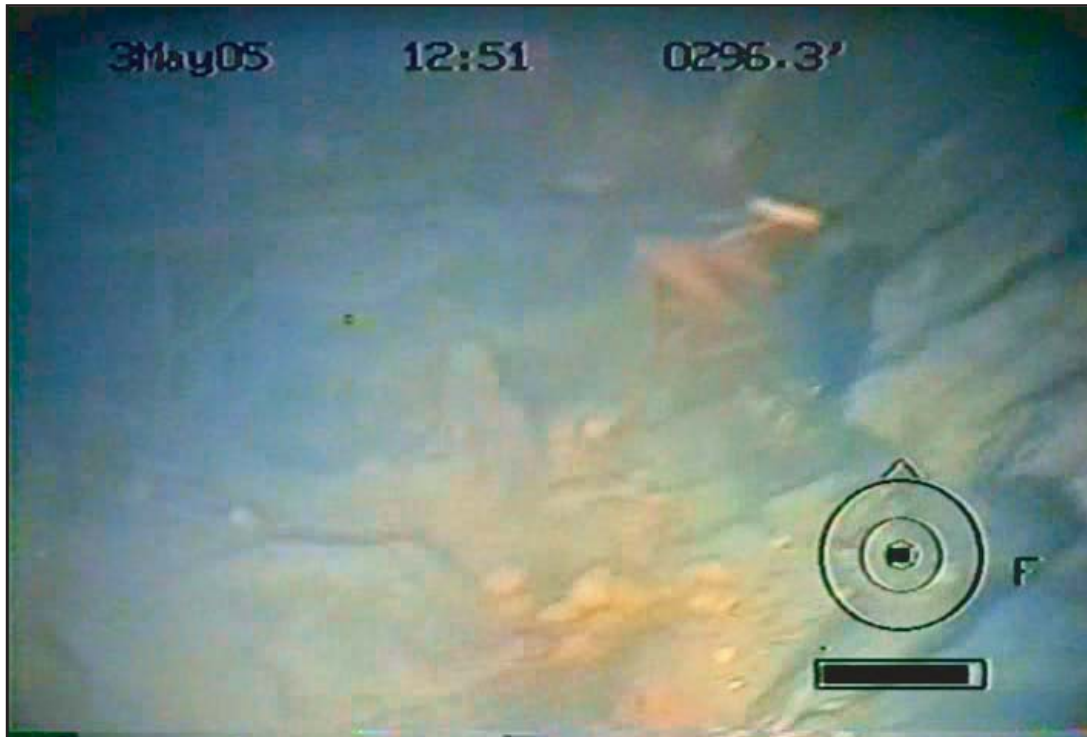
photo 8

End of video survey on 24-inch CMP Property Line storm pipe due to hole in pipe; located 296.3 feet west of SDMH 24A. Note: the tractor mounted video camera was underwater at time of survey.

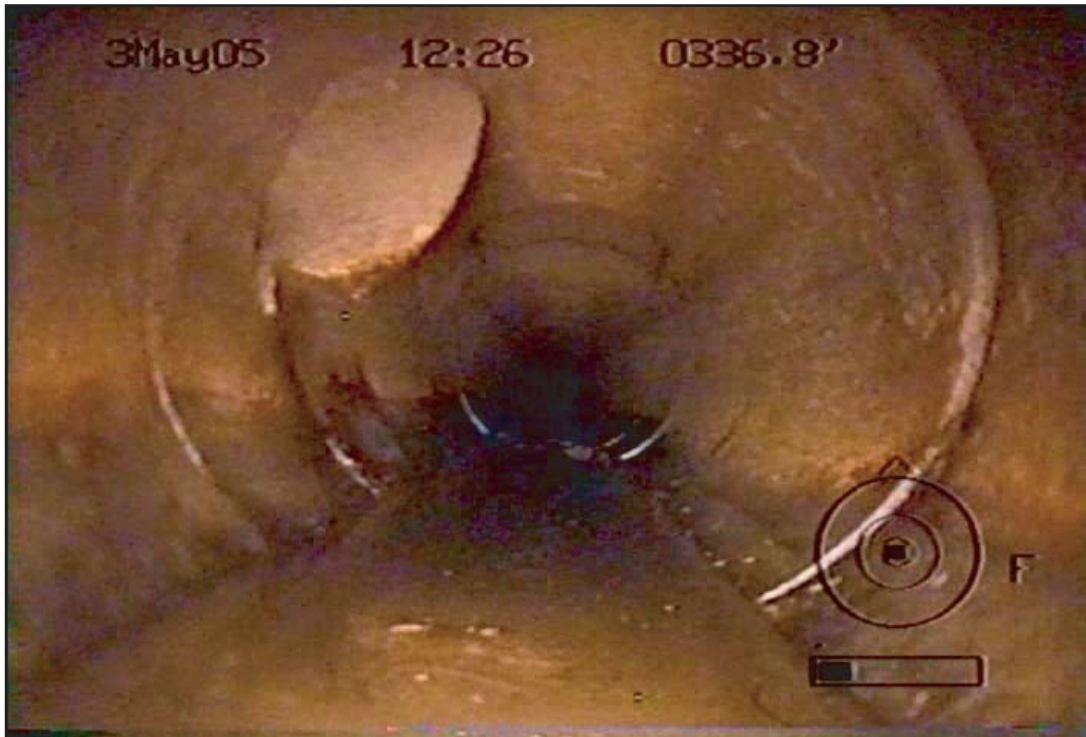
photo 9

View of 12-inch lateral pipe from Jorgensen connecting with 24-inch Property Line storm pipe, view facing west. SDMH 24A is also visible in this image.

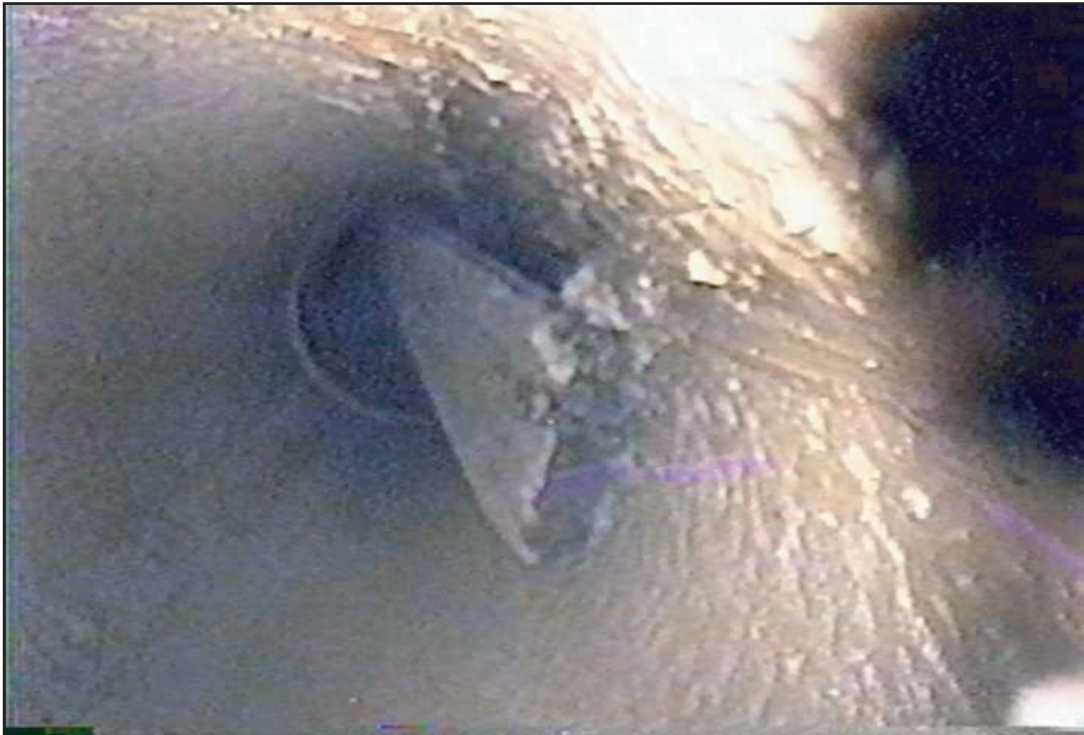
photo 10

View of dimensional lumber obstruction in the 12-inch storm pipe from Jorgensen connecting with the 24-inch Property Line storm pipe.
